Microstructural Analysis of Steel from the World Trade Center Buildings 7, & 1 or 2

Ronald R. Biederman, WPI

Higgins Armory/WPI MCSI Symposium
June 8, 2005

-The Role of Heat and Hot Corrosion in the Failure

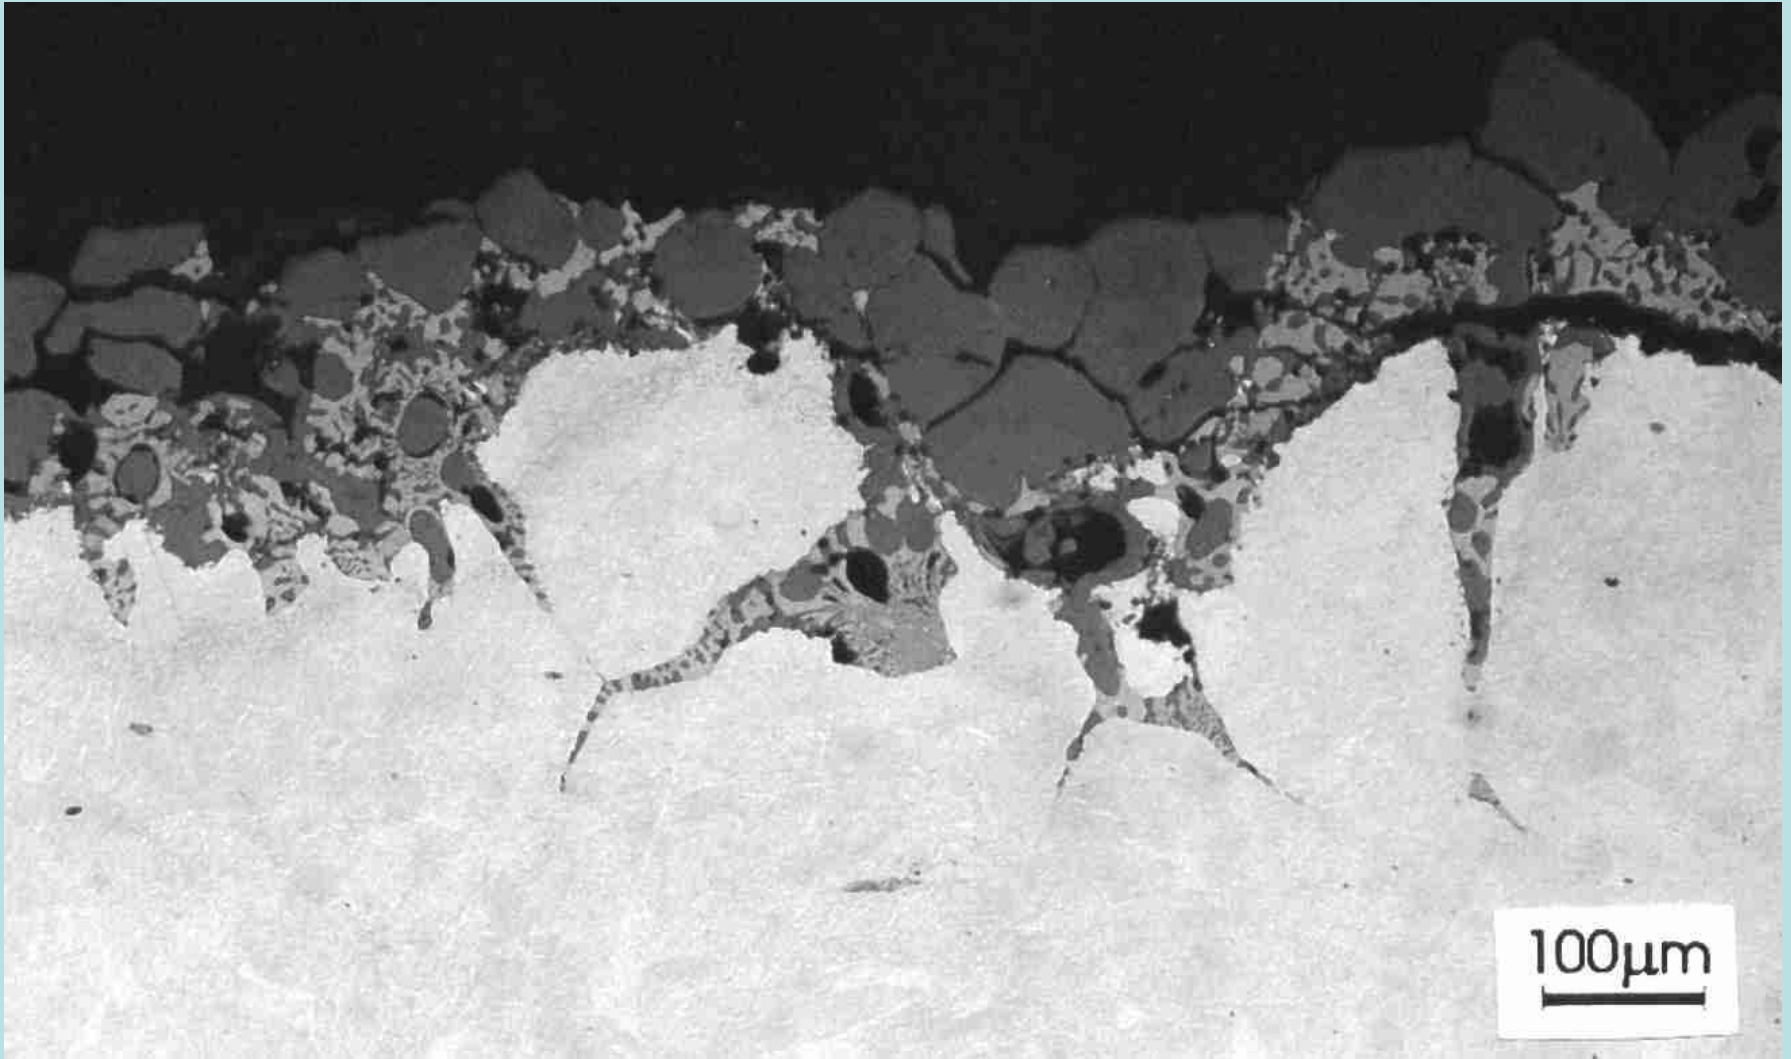
Oxidation and Intergranular Attack

Unetched

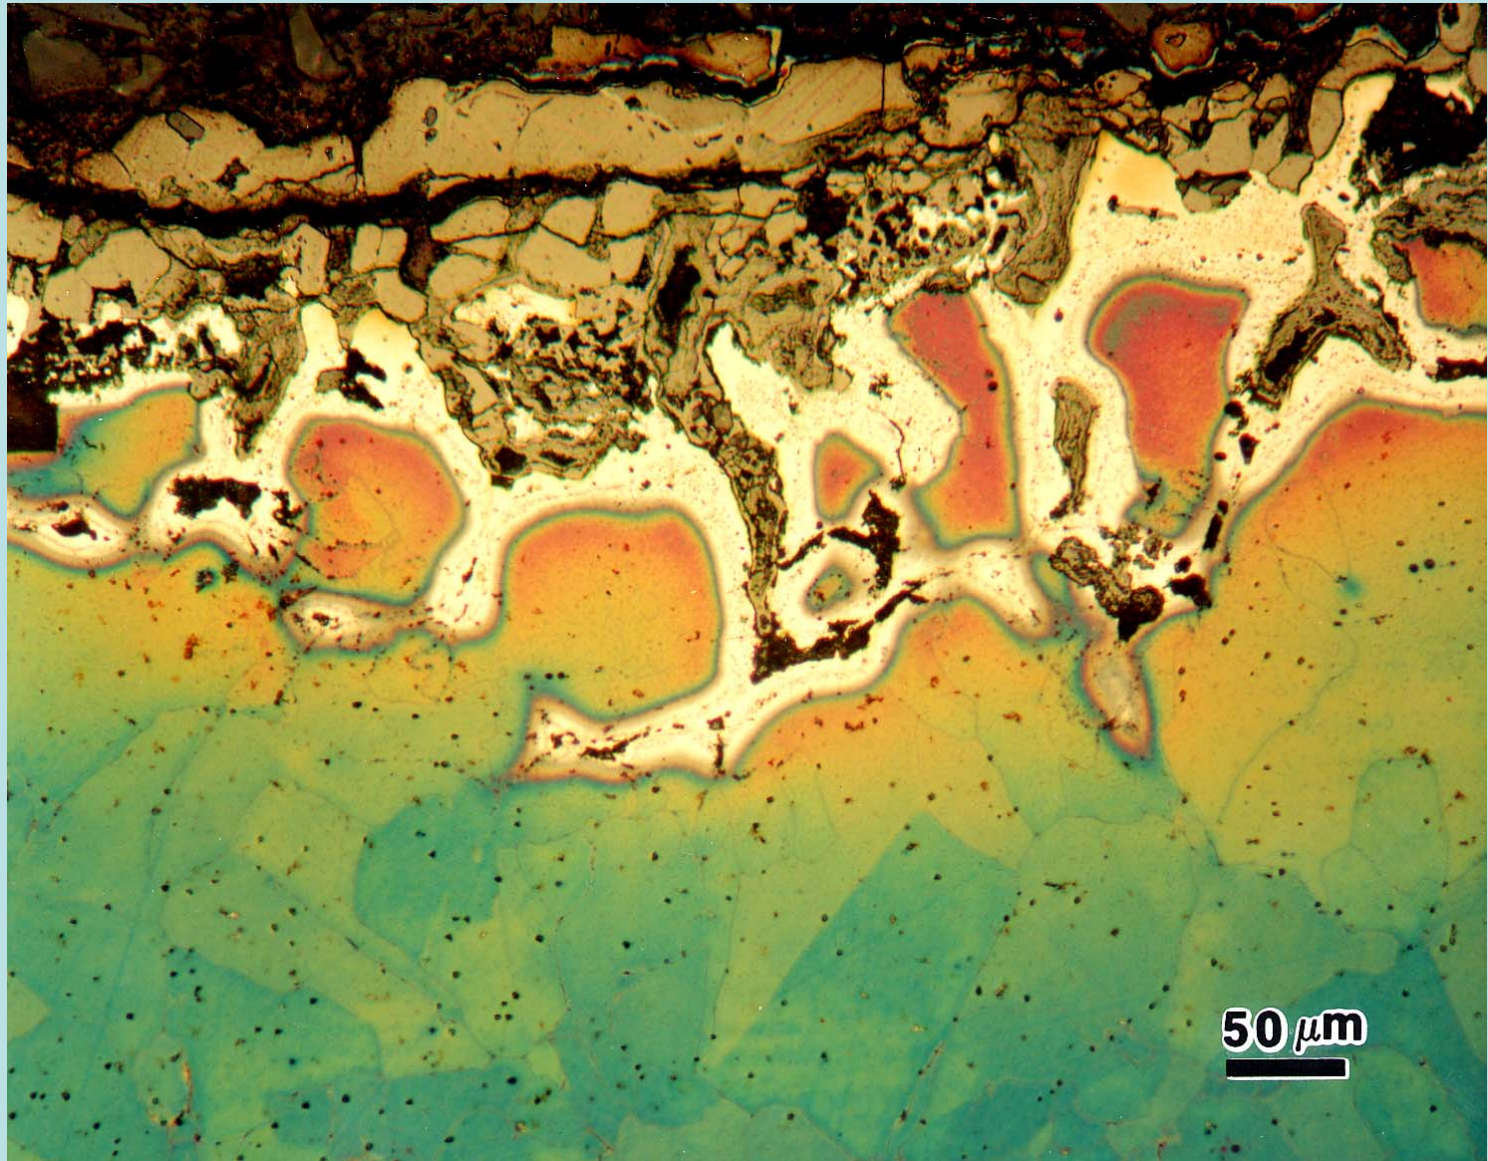
Oxygen-enrichment detection using Fine's alkaline chromate hot etch

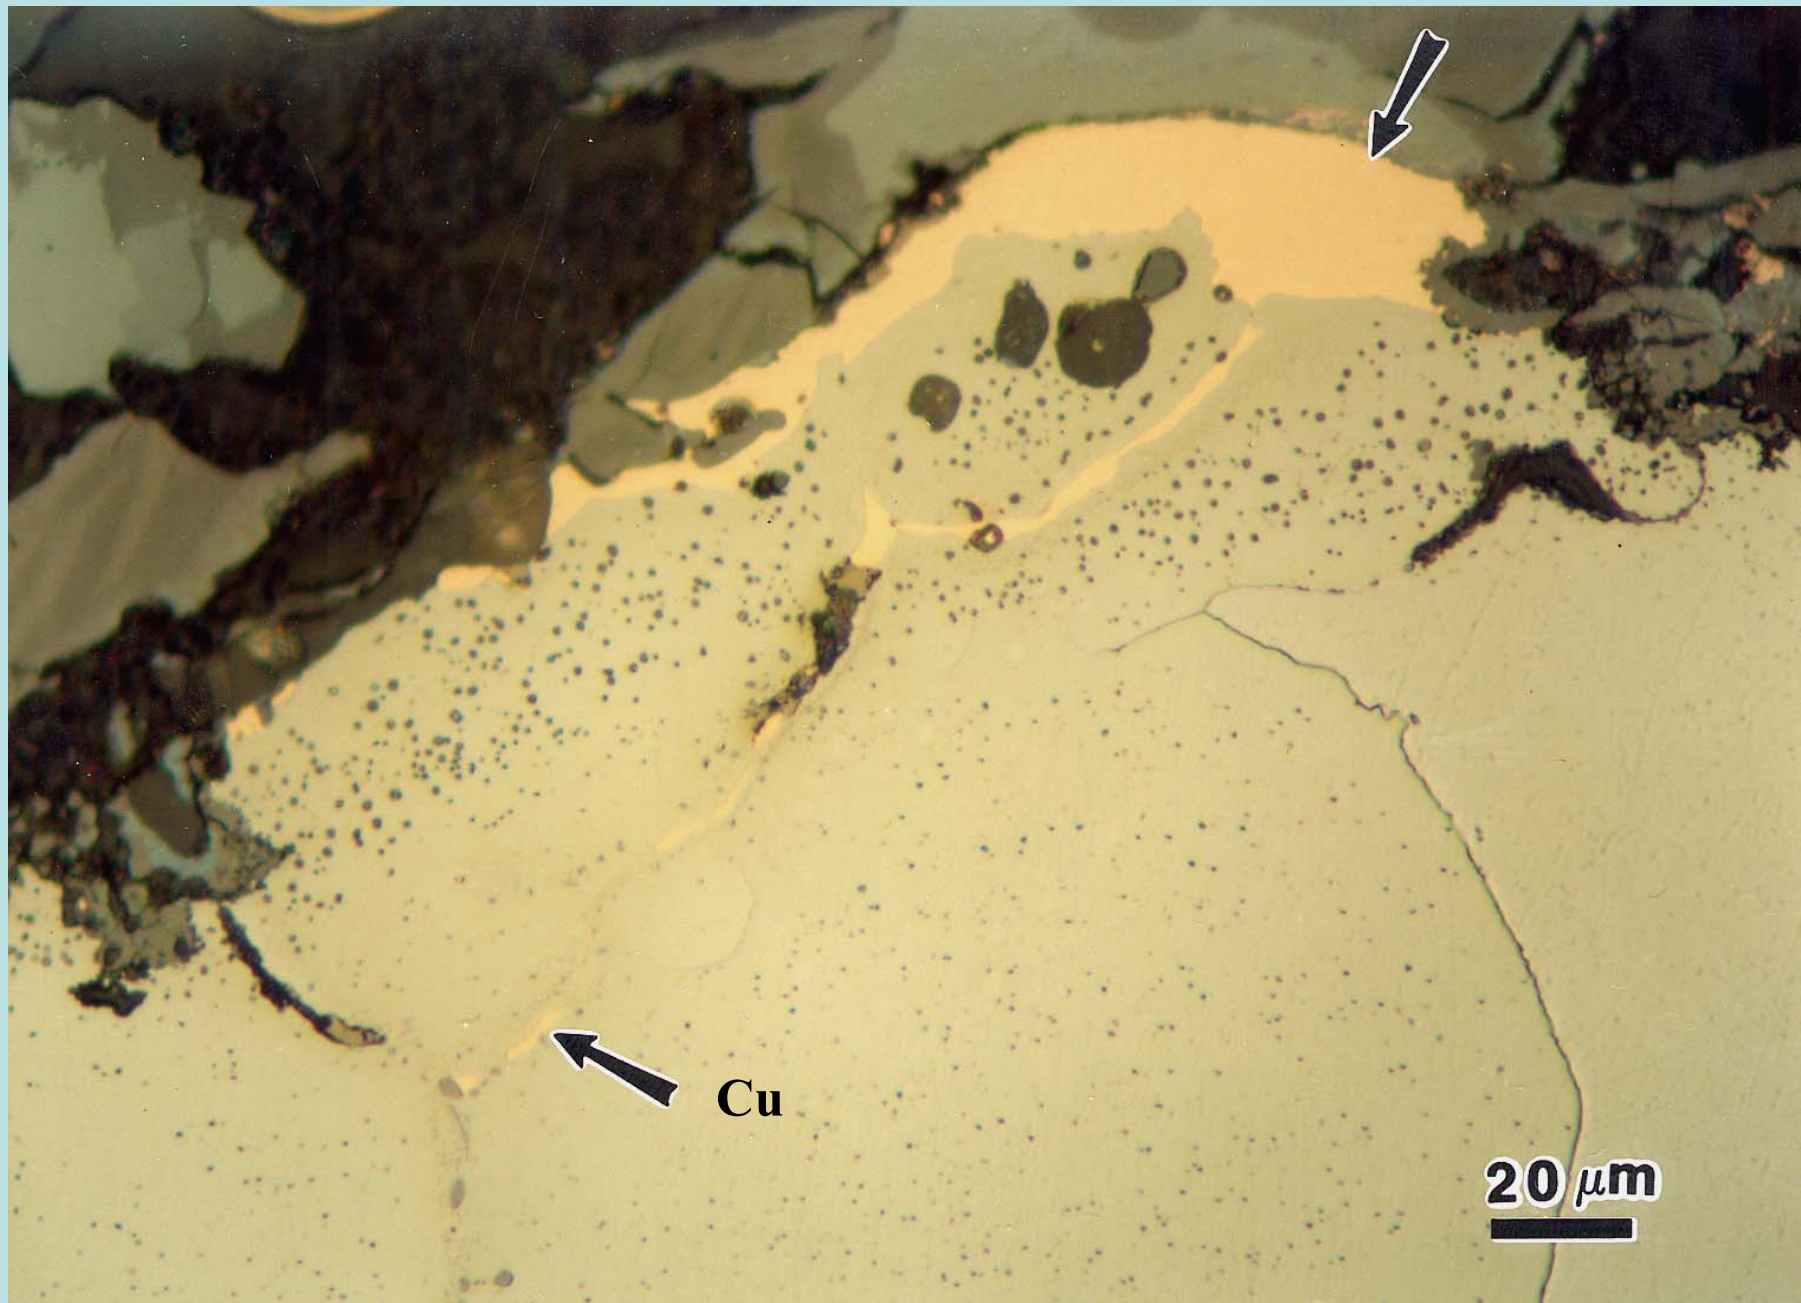
Microstructure of a Typical Region Showing the Surface and Grain Boundary Corrosion Attack of the HSLA Steel

1. **The severe thinning of the HSLA steel occurred by high temperature corrosion due to a combination of oxidation and sulfidation.**
2. **Sulfidation of the grain boundaries in the HSLA steel accelerated the corrosion and erosion of the steel.**

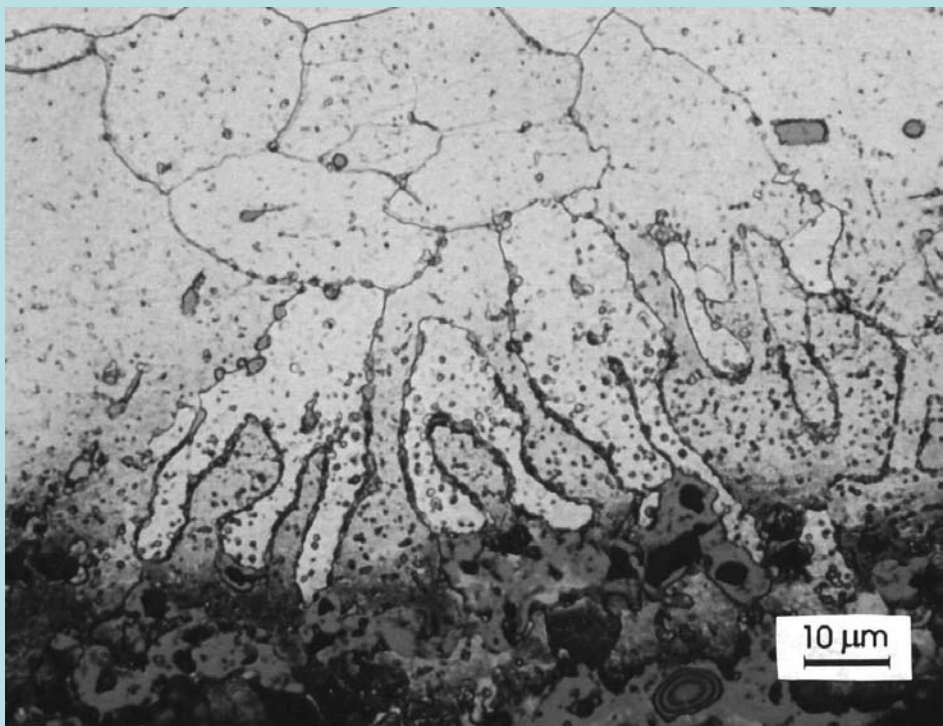
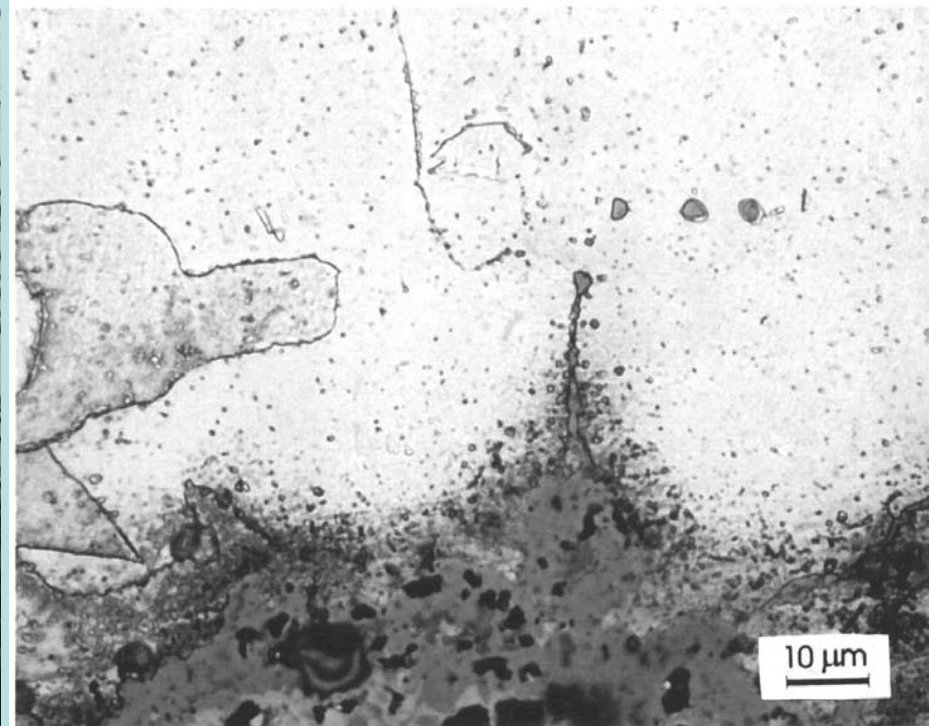
Manganese, Carbon, Silicon, Copper, and Sulfur Segregate at Interfaces where Reaction is Severe

Gradient of Sulfides into the Steel from the Oxide-Metal Interface

- 1. The severe thinning of the HSLA steel occurred by high temperature corrosion due to a combination of oxidation and sulfidation.**
- 2. Sulfidation of the grain boundaries in the HSLA steel accelerated the corrosion and erosion of the steel.**
- 3. The high concentration of sulfides in the grain boundaries in the corroded regions of the steel occurs due to copper diffusing from the HSLA steel combining with iron, manganese and sulfur making both discrete and continuous sulfides in the steel grain boundaries.**
