Microstructural Analysis of Steel from the World Trade Center Buildings 7, & 1 or 2

Ronald R. Biederman, WPI

Higgins Armory/WPI MCSI Symposium
June 8, 2005

-The Role of Heat and Hot Corrosion in the Failure

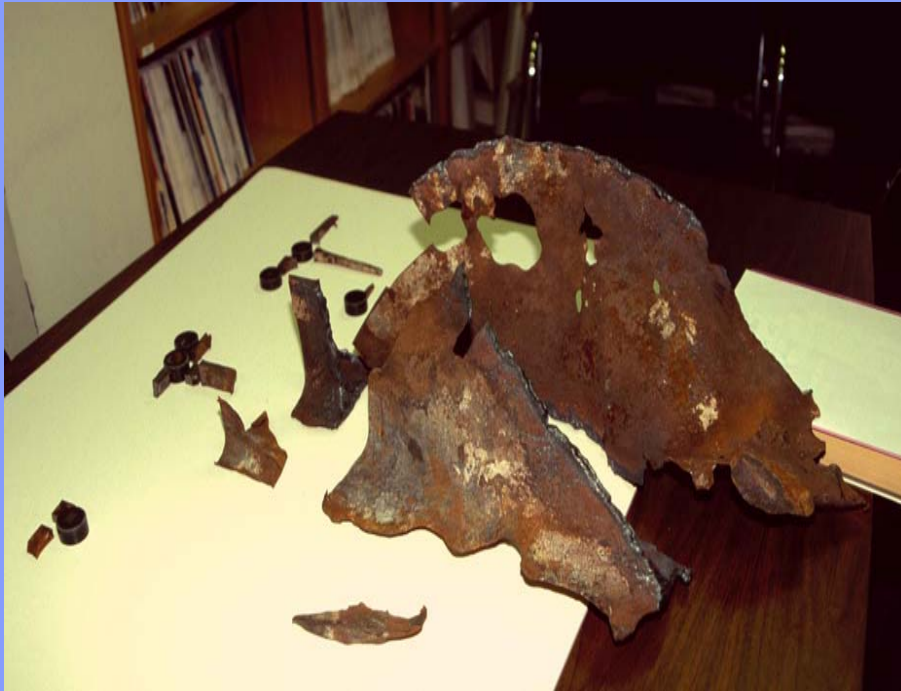
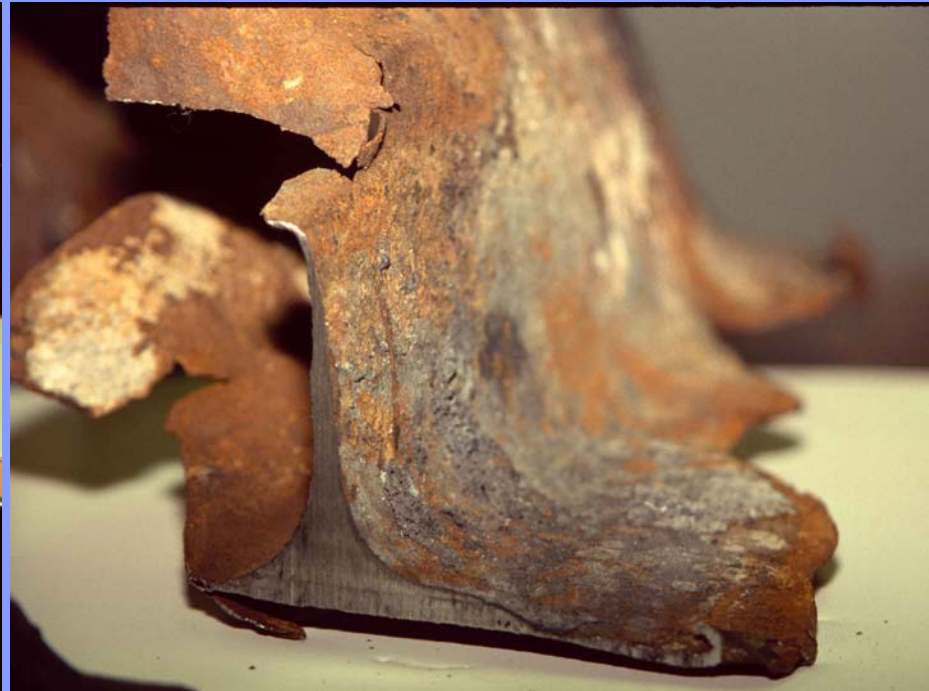
Severely Eroded $\frac{1}{2}$ " Wide Flange Beam from WTC 7

- 1. Rapid deterioration of the A36 steel was a result of hot corrosion.**

- 1. Rapid deterioration of the A36 steel was a result of hot corrosion.**
- 2. Heating in an environment containing oxygen and sulfur resulted in intergranular melting which transformed to an Iron Oxide and Iron Sulfide eutectic mixture on cooling .**

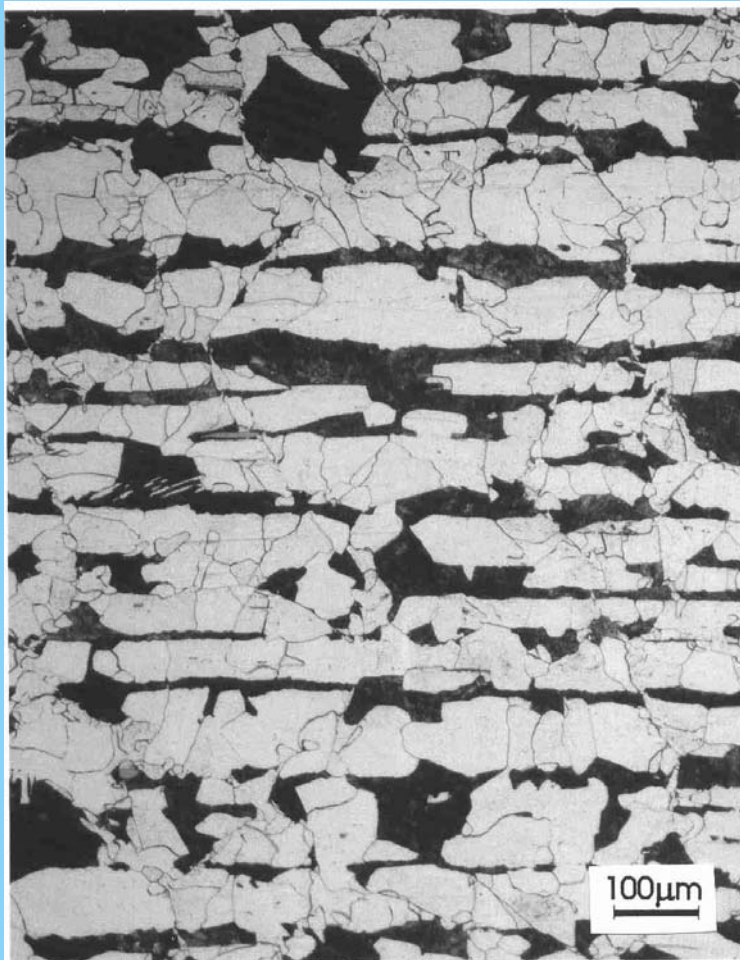
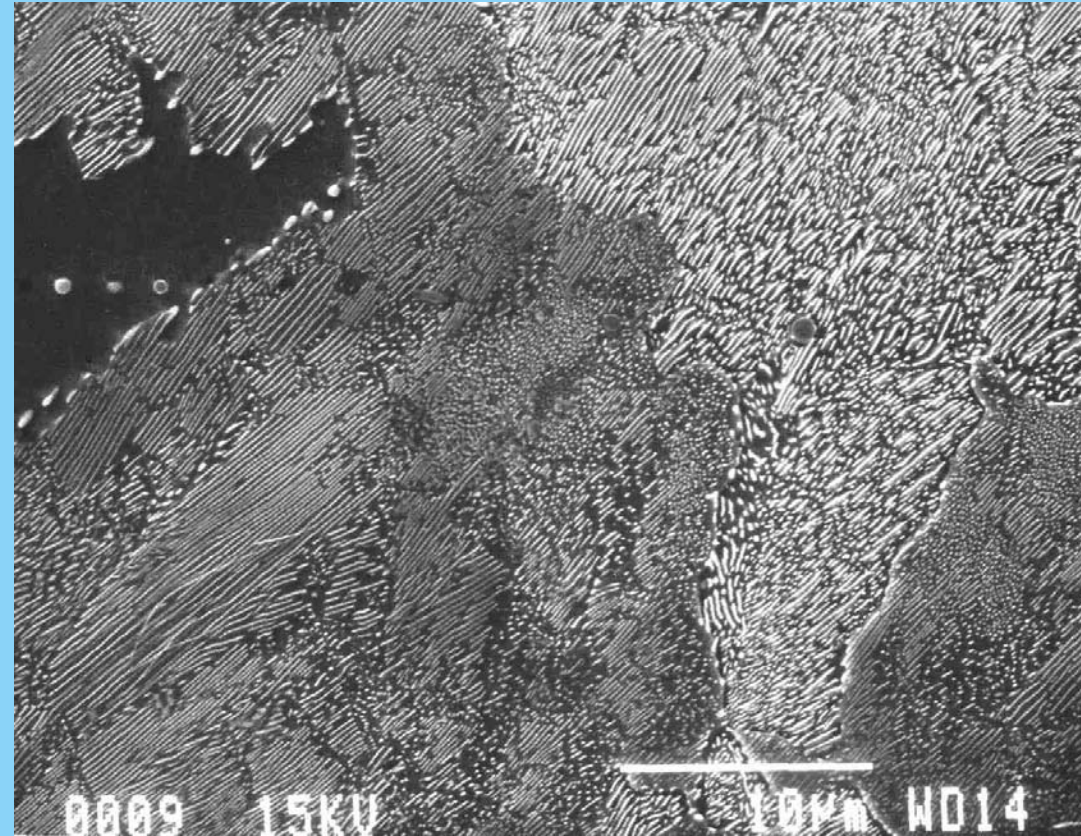
Microstructure of Unaffected A36 Steel

White - Ferrite, Dark - Banded Pearlite

Pearlite forms in bands due to manganese segregation and prior hot working

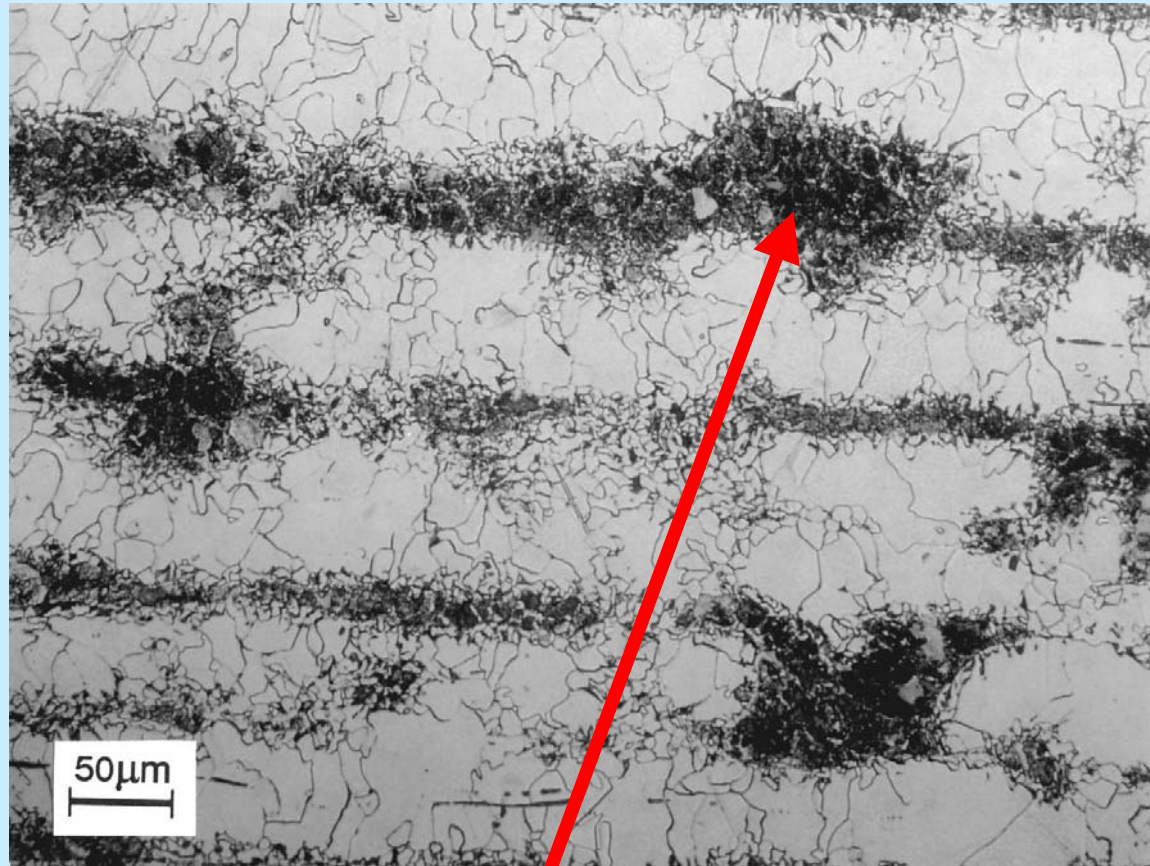
Typical Microstructural Changes That Occur When A36 Steel is Heated to the Vicinity of the Eutectoid Reaction $\sim 727^{\circ}\text{C}$ (1340°F), Held for a Short Time, and Cooled to Ambient Temperature

Partial Carbide Spheroidization

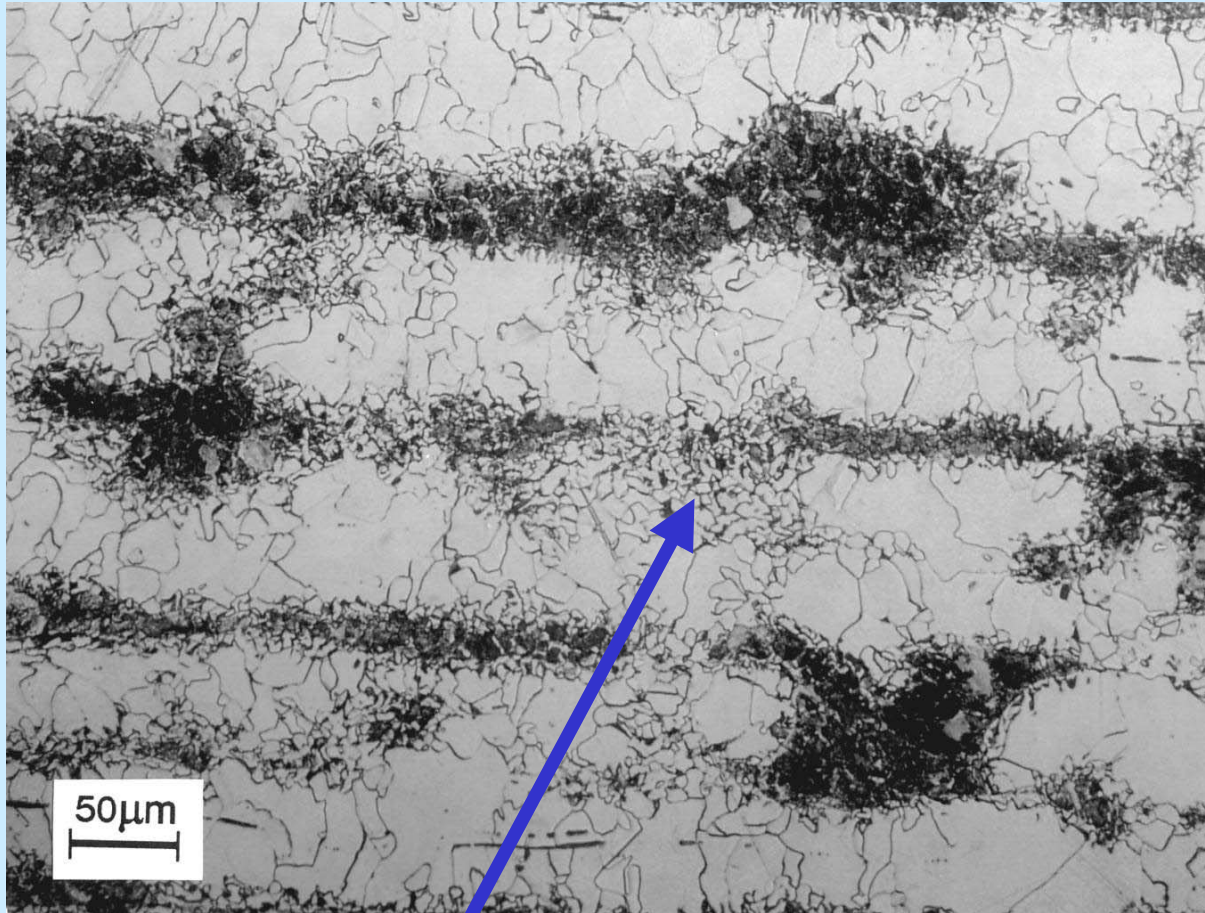
Typical Microstructural Changes That Occur When A36 Steel is Heated to the Vicinity of the Eutectoid Reaction $\sim 727^{\circ}\text{C}$ (1340°F) and cooled to Ambient Temperature

A Typical Region Where Conversion to an Austenite Matrix (on Heating) Occurred Followed by a Retransformation to a Ferrite Matrix on Cooling

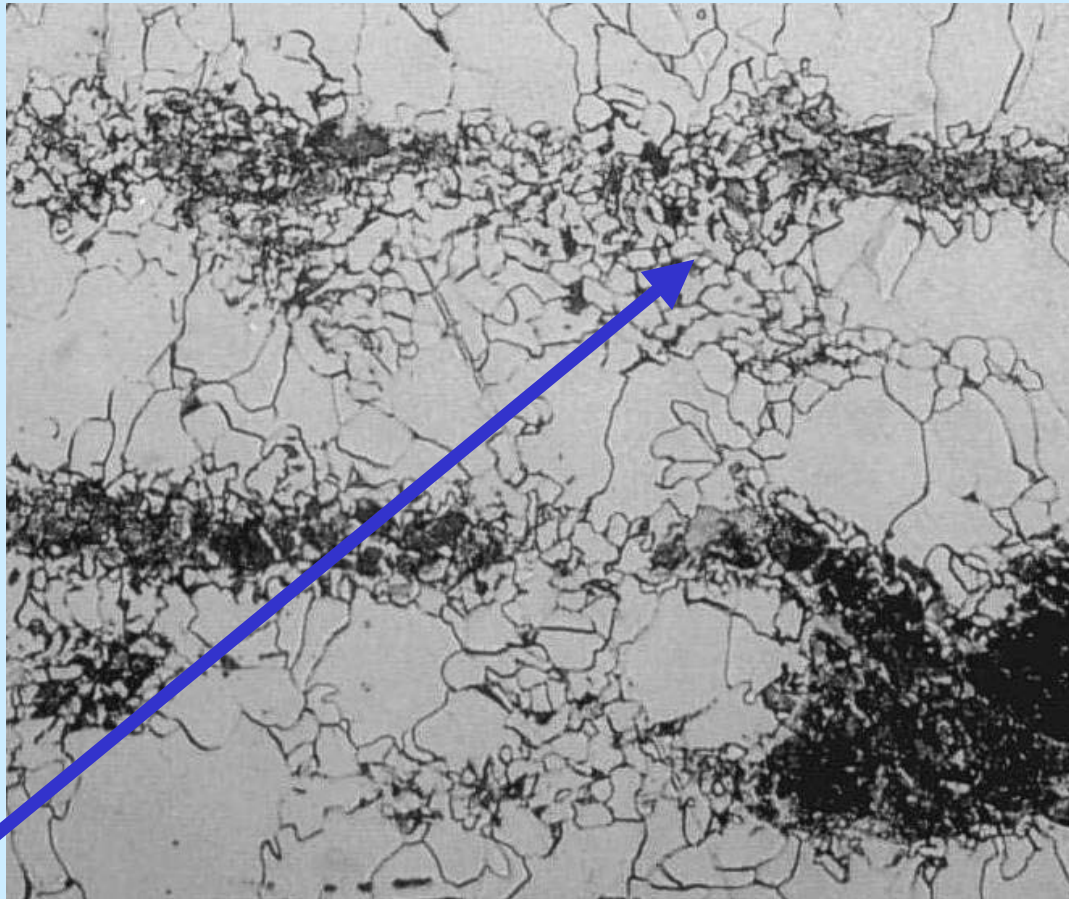
Typical Microstructural Changes That Occur When A36 Steel is Heated to the Vicinity of the Eutectoid Reaction $\sim 727^{\circ}\text{C}$ (1340°F) and cooled to Ambient Temperature

Conversion to Austenite Matrix (on heating) and Return to Ferrite Matrix (on Cooling)

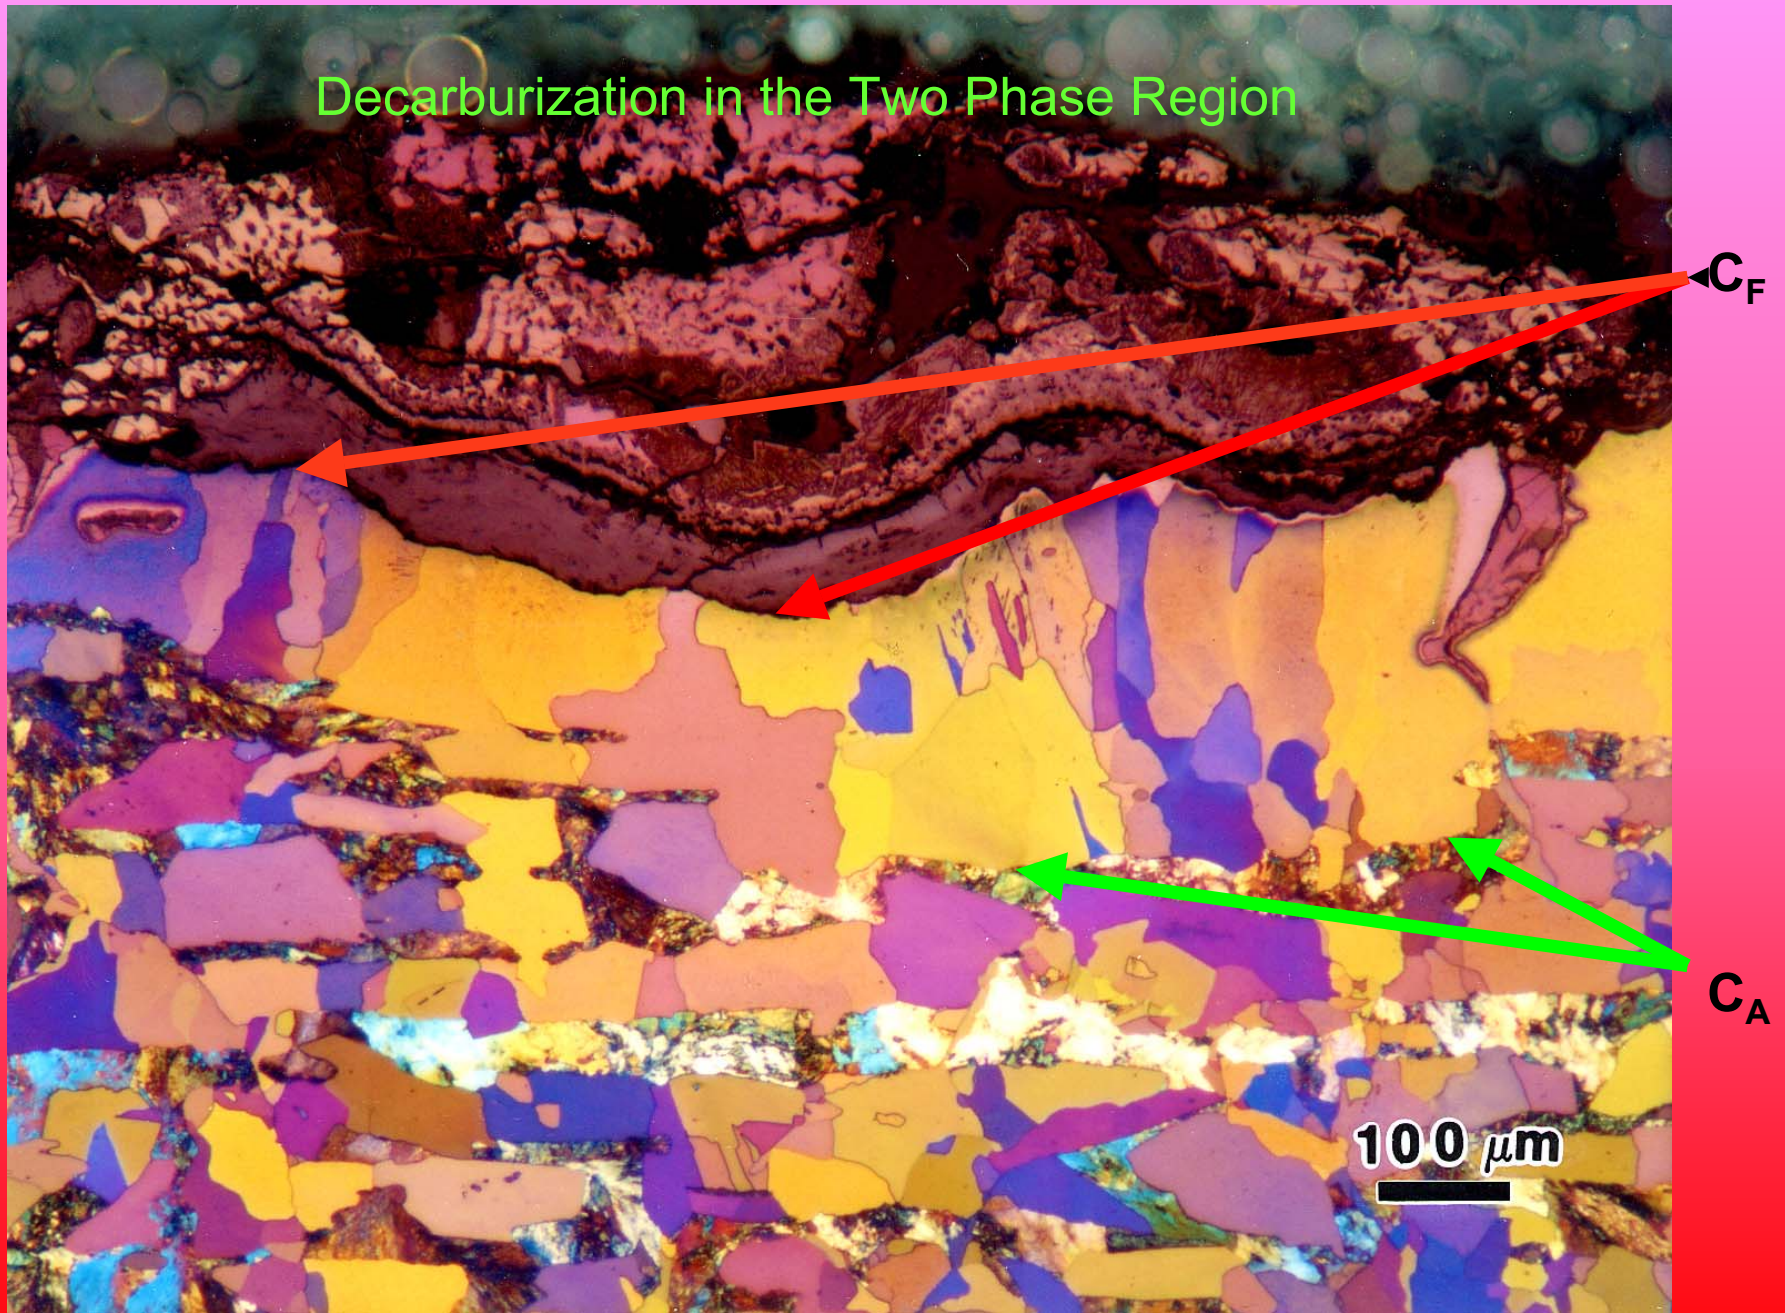
Decarburization in the Two Phase Region

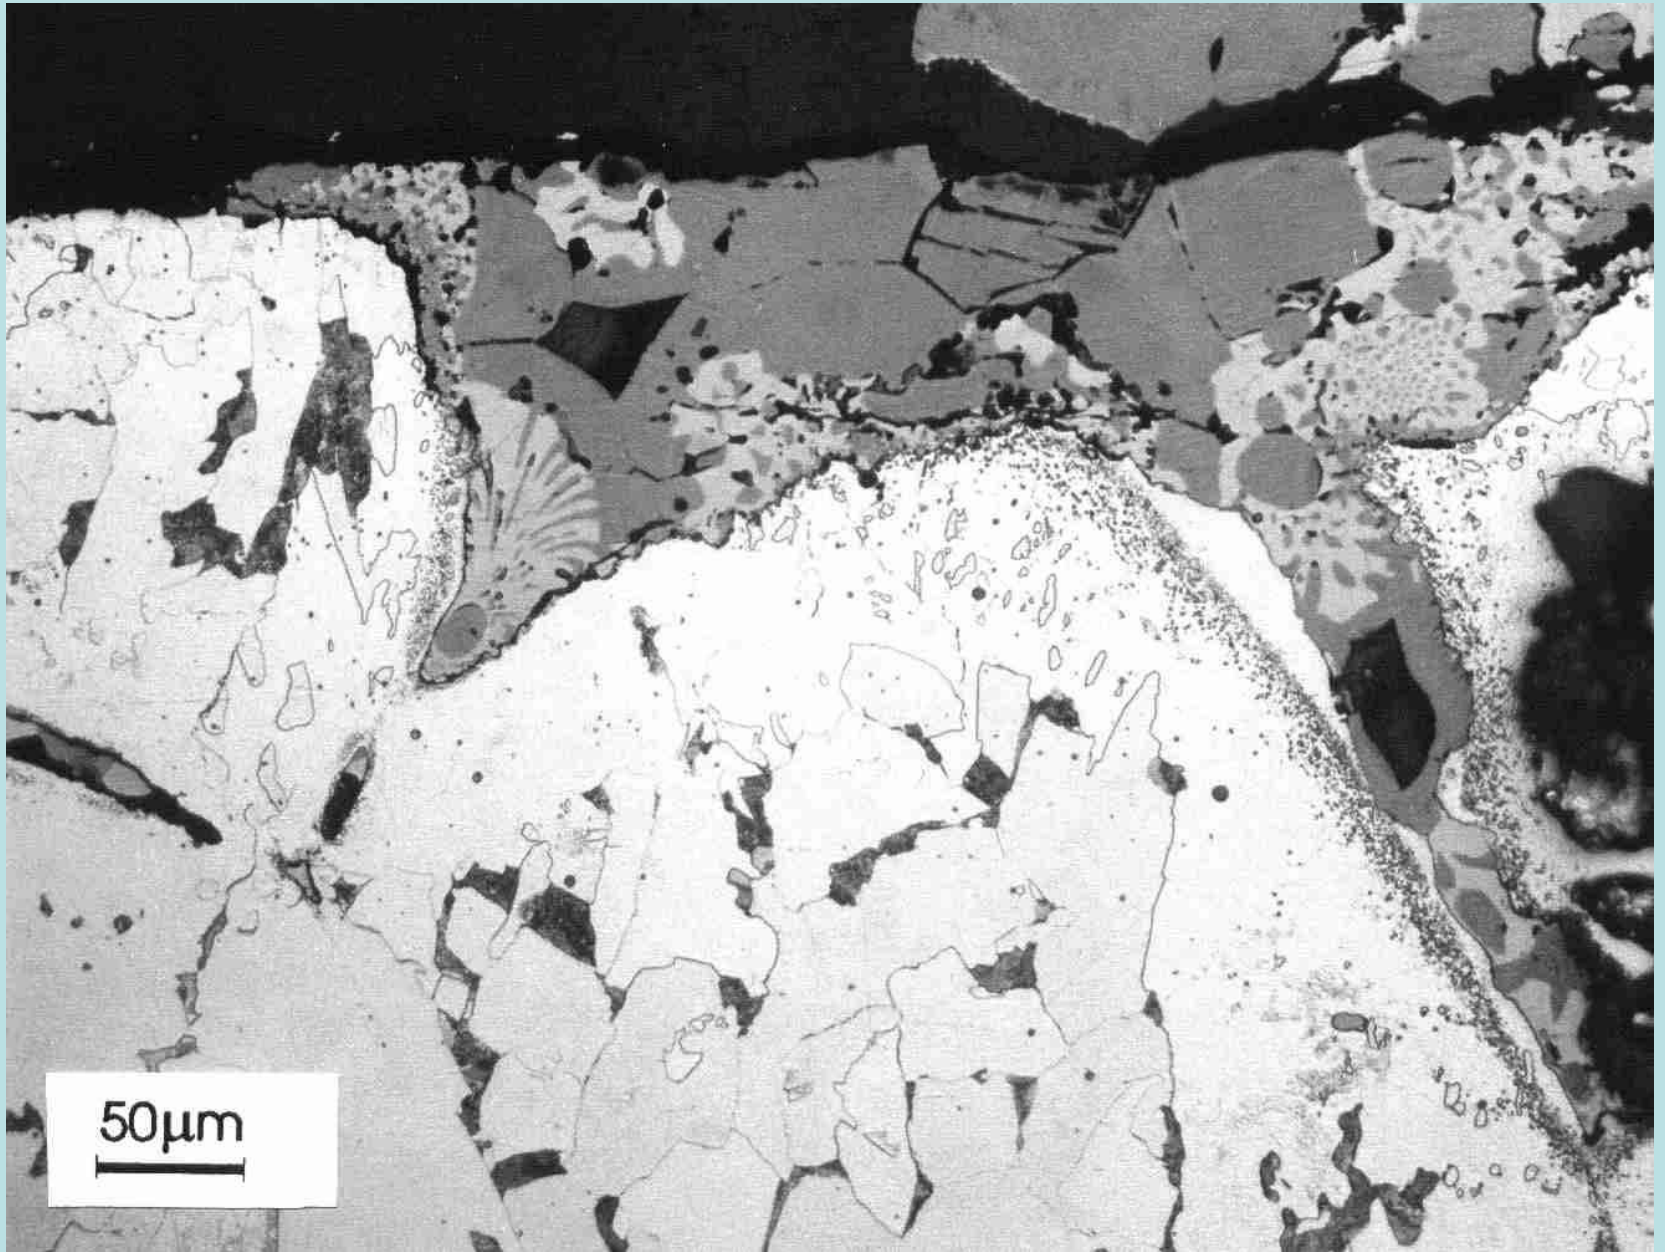
Oxygen-enrichment detection using Fine's alkaline chromate hot etch

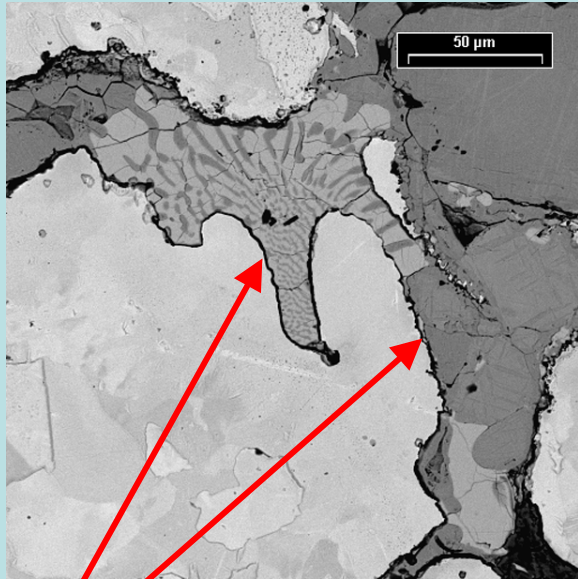
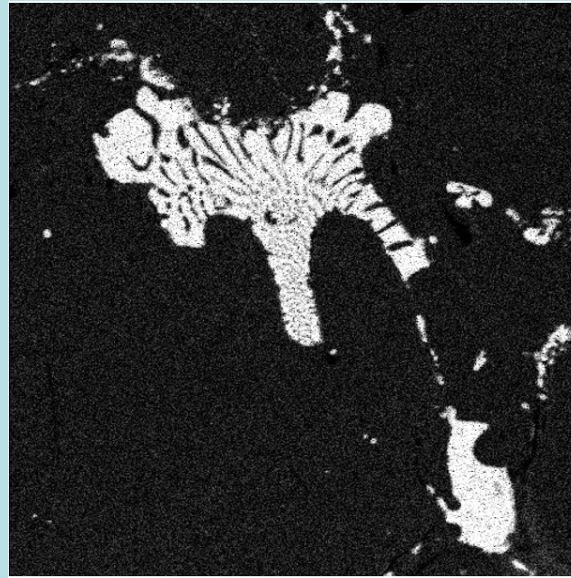
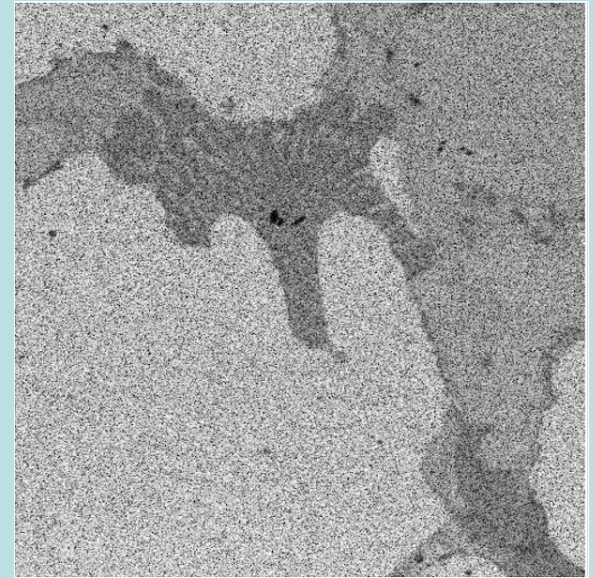
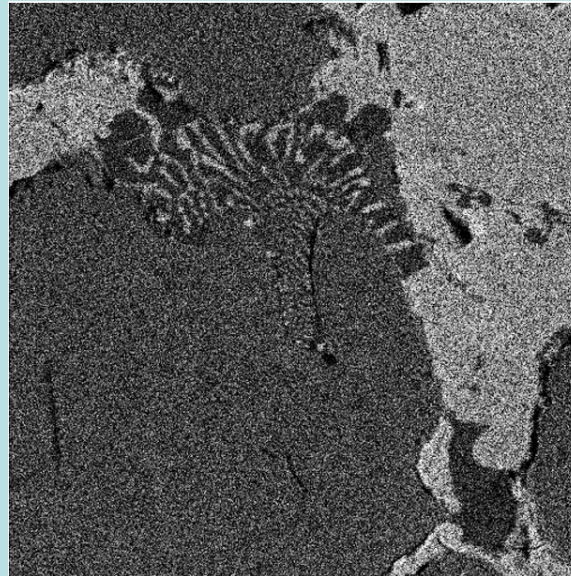
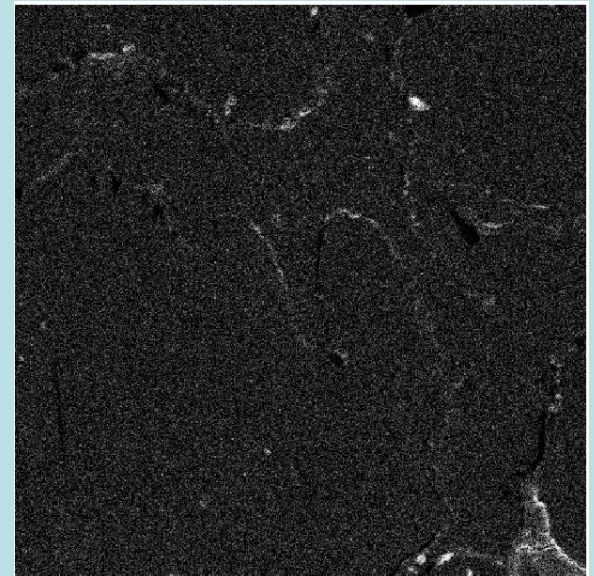
Digital X-Ray Map of the Eutectic Reaction Product

Carbon, Silicon and Sulfur are Segregated at Interfaces

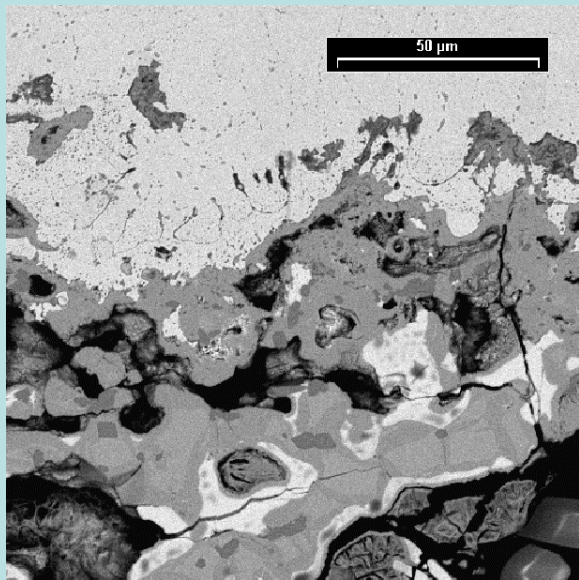
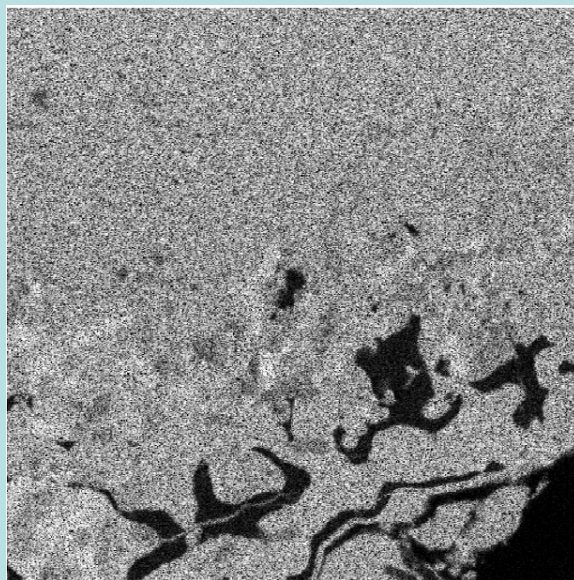
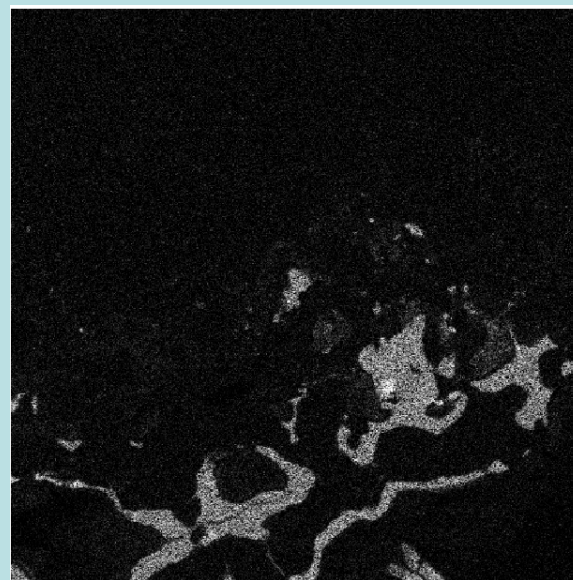
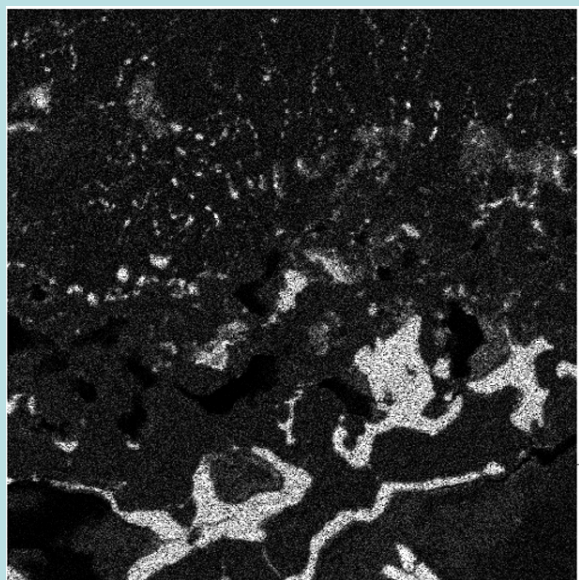
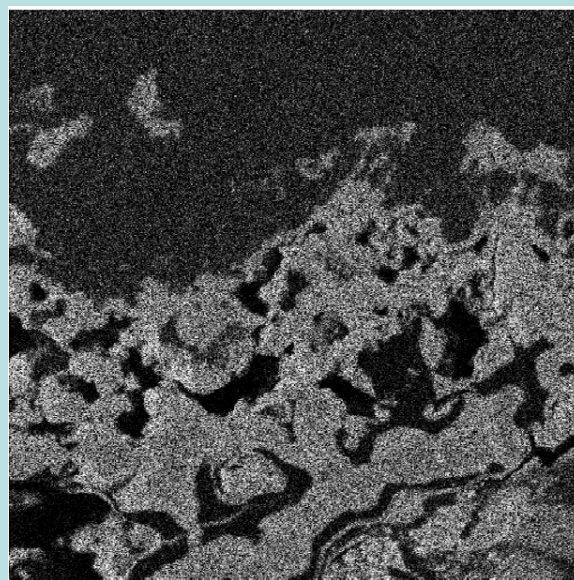
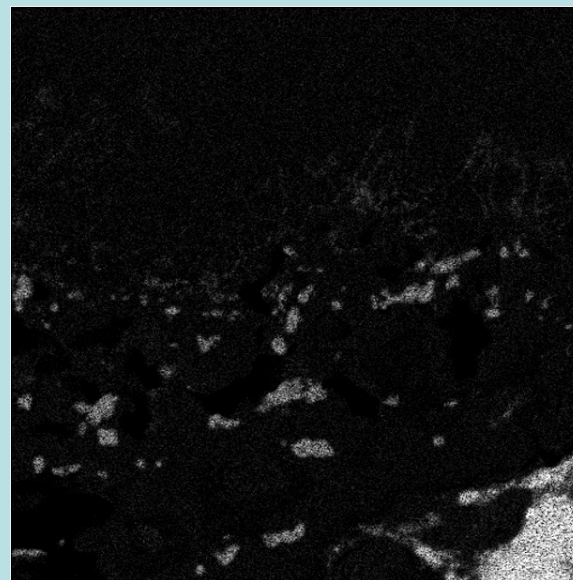
Higher Magnification of the Surface Reaction Region

Microstructure of a Typical Region Showing the Surface and Grain Boundary Corrosion Attack of the HSLA Steel

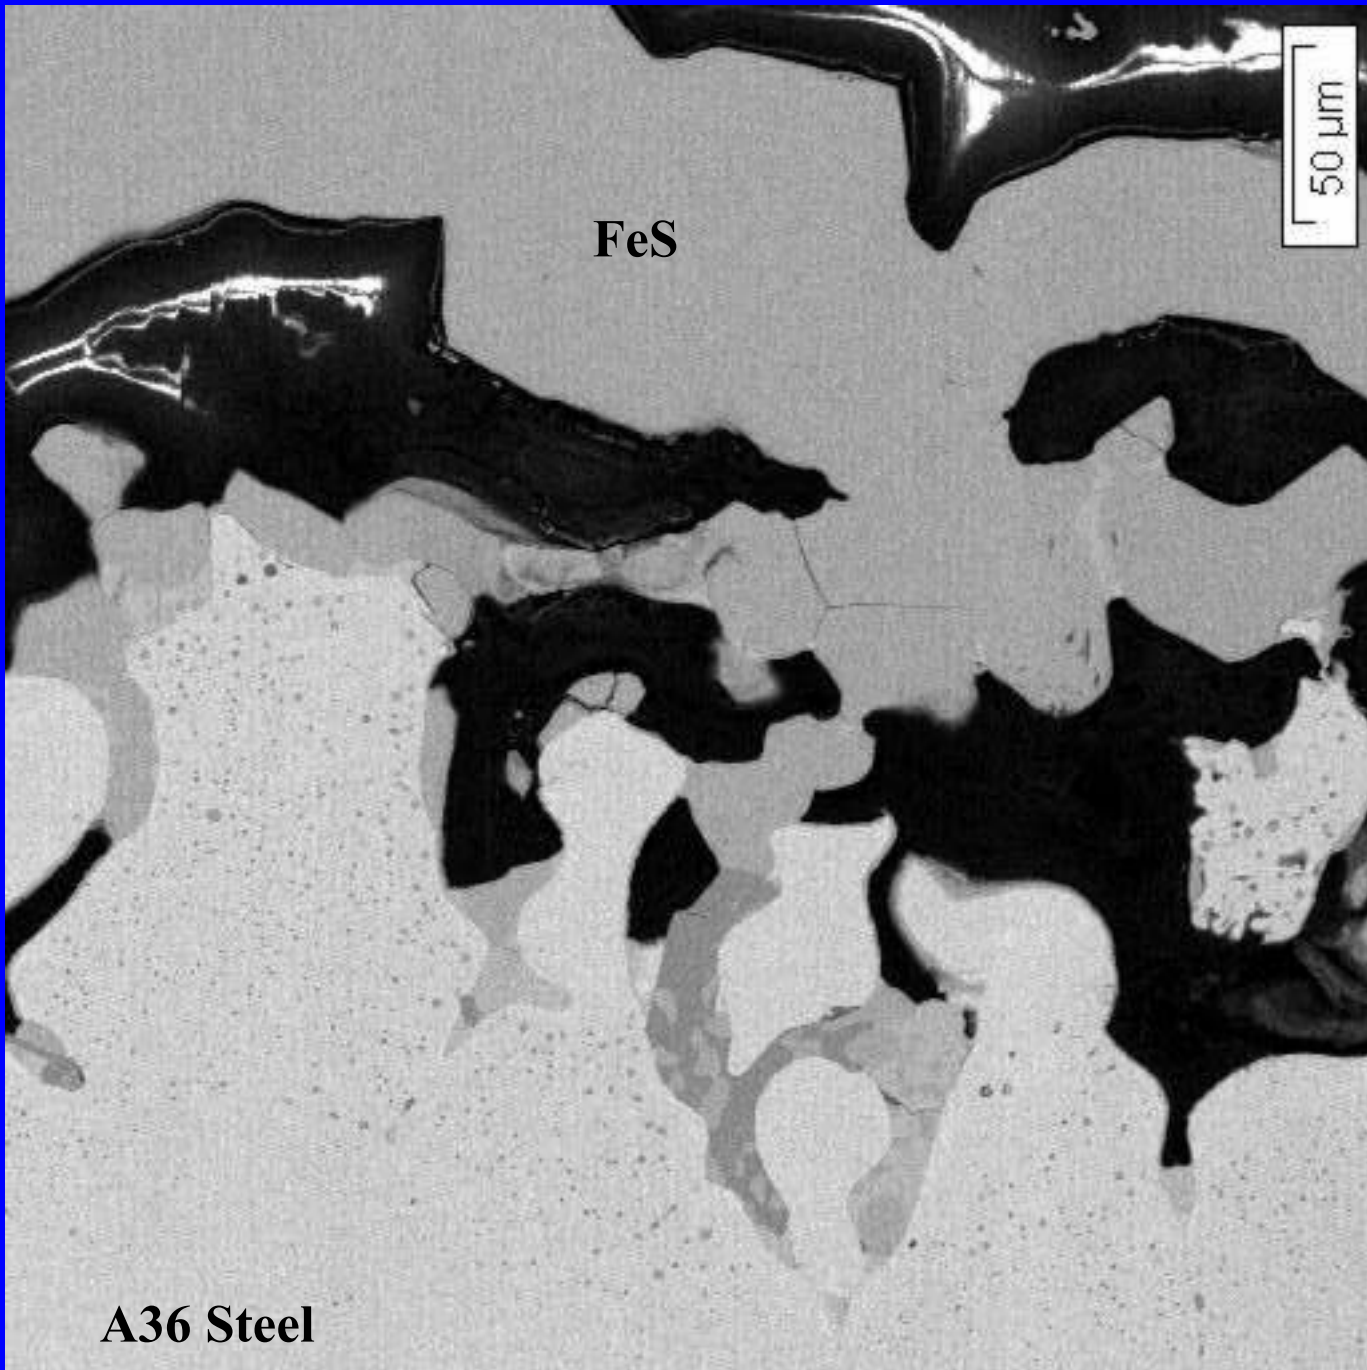
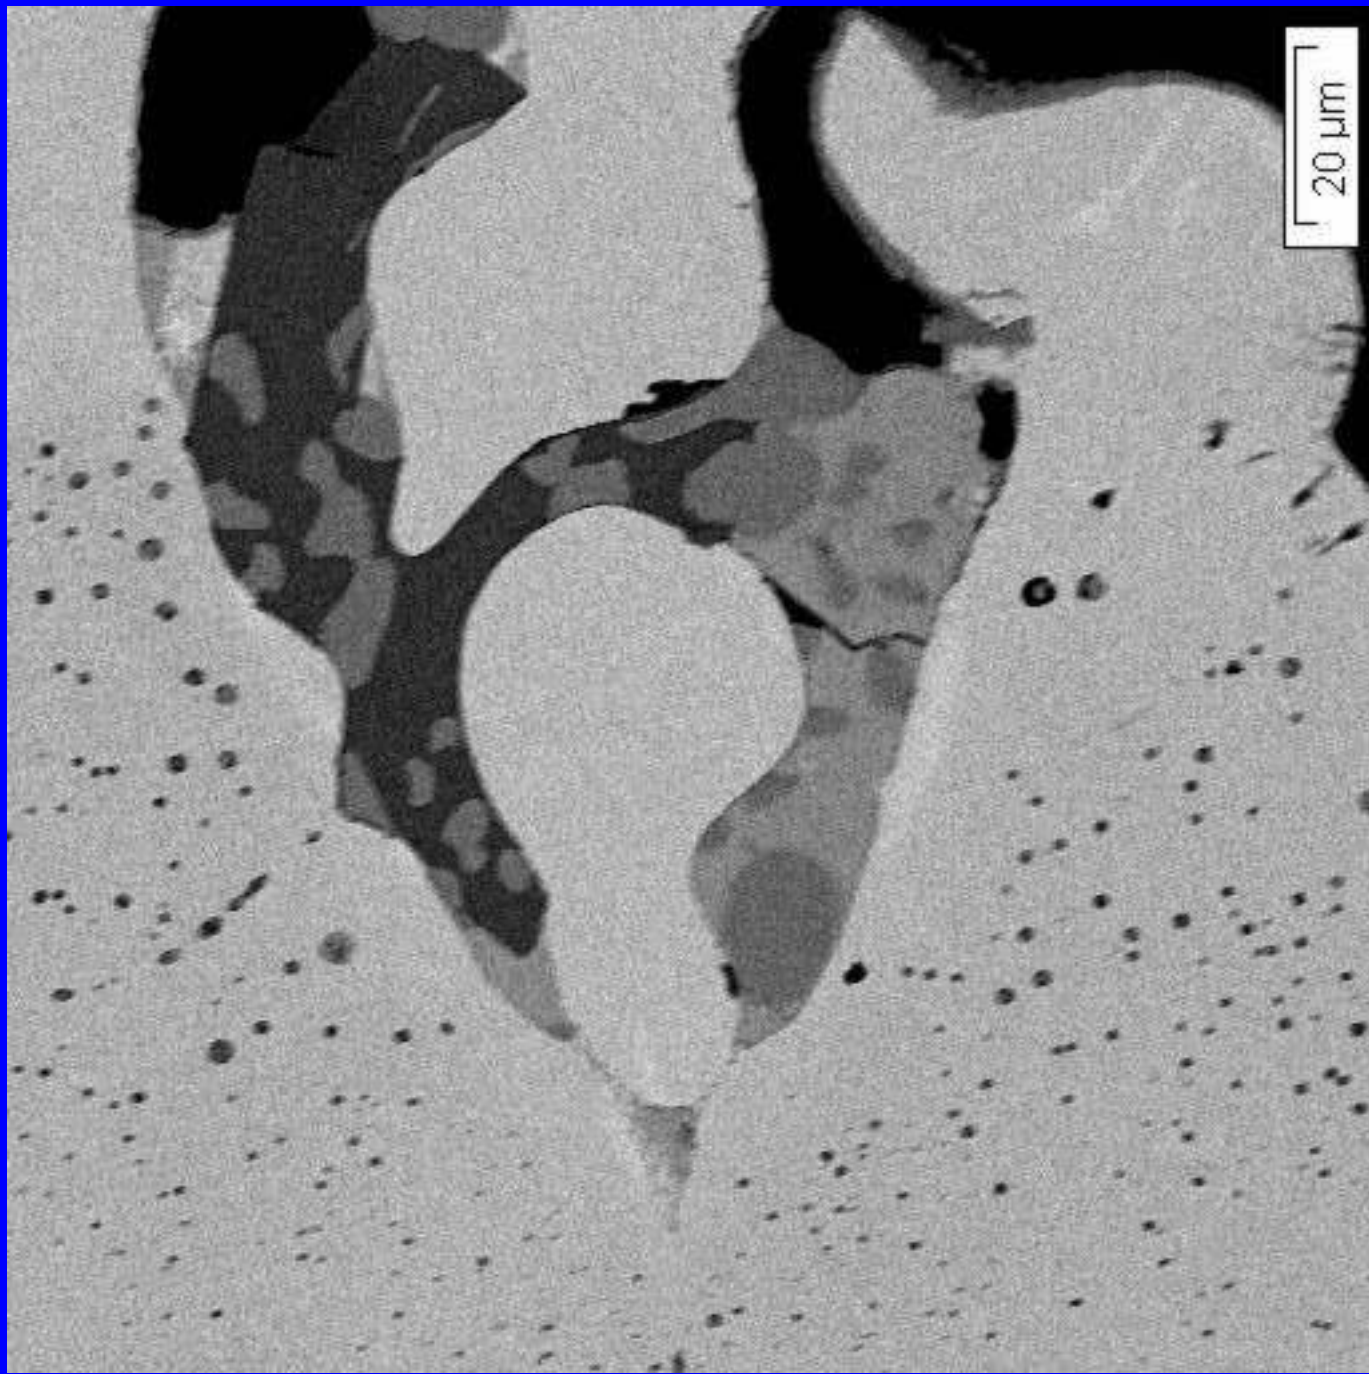
**Isothermal Reaction of Compacted
FeS Powder on the Ground Surface of
A36 In Air for 12 Hours at 1100C.**
